SPECIAL NOTICE

COMET • FALCON 1960-66

MUSTANG 1965-66

IMPROPER INSTALLATION TIE ROD ENDS CAUSE STEERING LINKAGE BIND

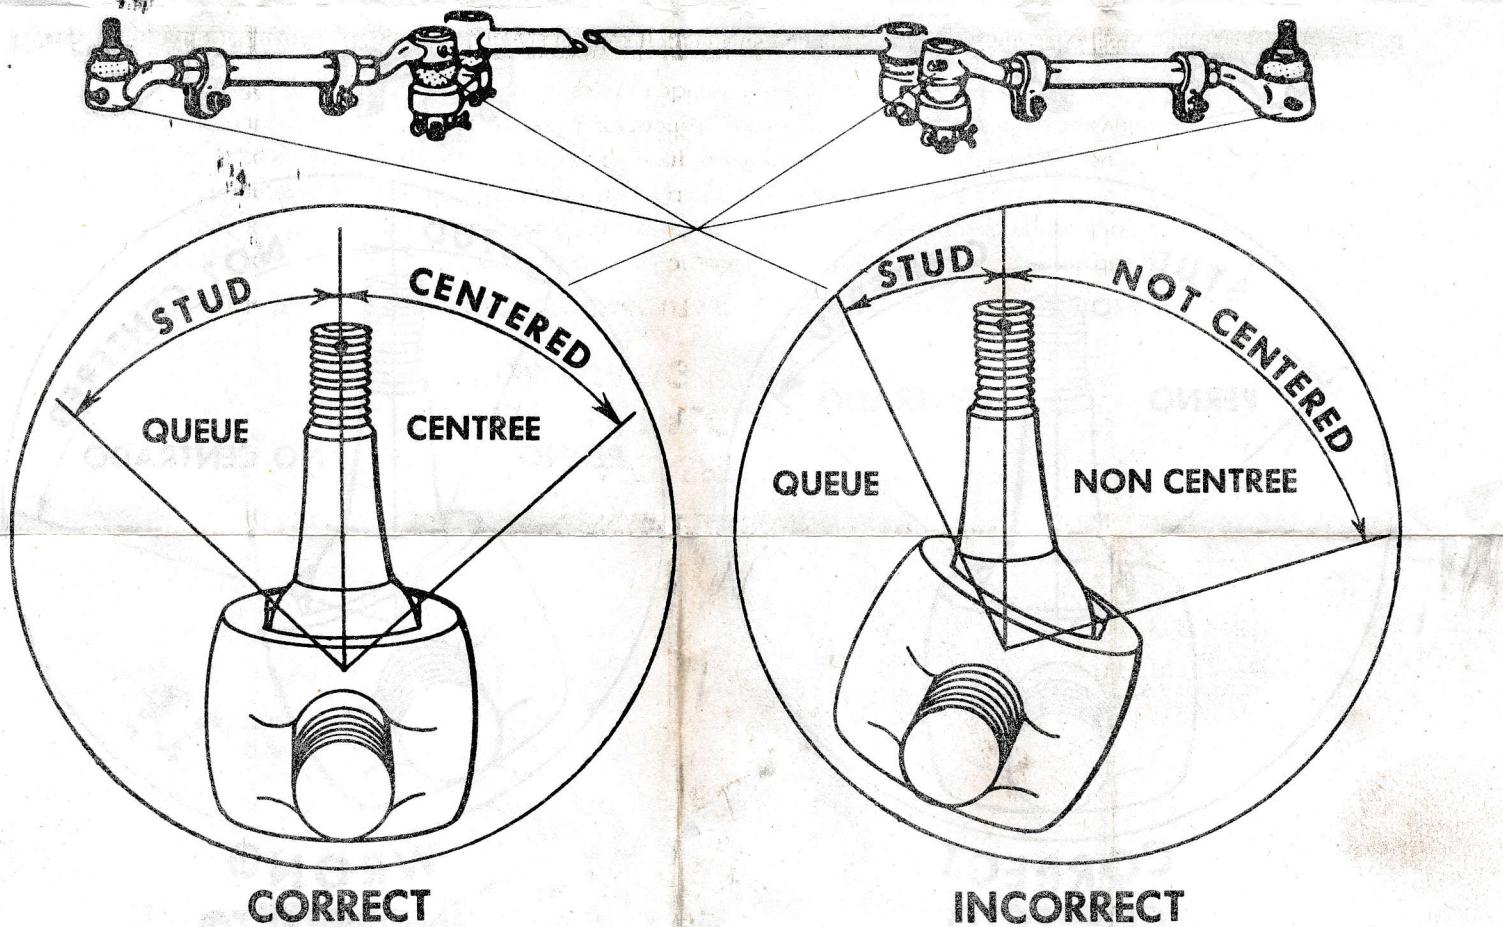
When replacing tie rod ends or performing wheel alignment on MUSTANG, FALCON or COMET cars, special attention should be given to positioning of components. (See illustration.) Failure to center tie rod end studs to permit full stud swing can cause binding of the steering linkage resulting in unnecessary wear and in extreme cases failure of the tie rod end.
