1967 - 1969 Wagner Brake Pressure Differential Valve Rebuild

This document describes how to rebuild the Wagner brake pressure differential valve (sometimes called a "distribution block") and front disk brake pressure control valve (sometimes called a "proportioning valve") used on Ford and Lincoln/Mercury vehicles by replacing the internal parts that typically wear out after years of service. Tools needed:

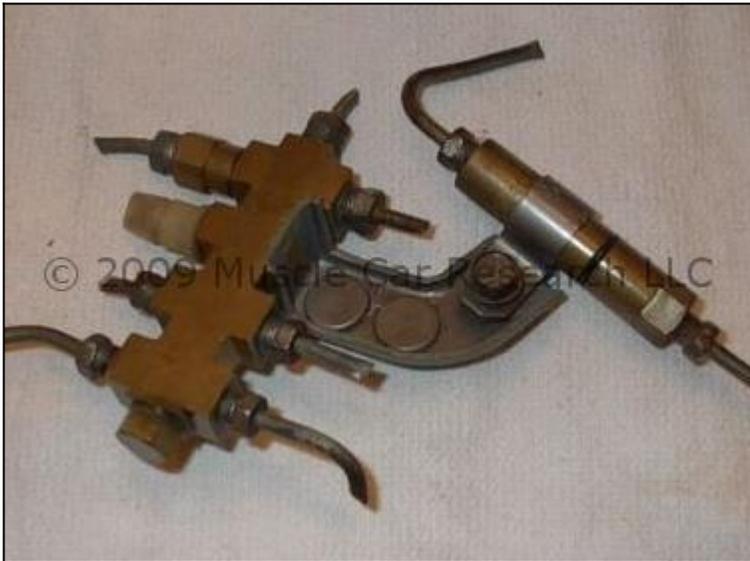
Arrange your valve, tools, and rebuild kit on a clean work surface. Let's get started! The first step is to inspect the valve and make sure that the exterior is undamaged. Check the port threads for damage. Make sure the valve is securely attached to the mounting bracket. A loose mounting bracket can be tightened up by lightly tapping the brass mounting tab with a ball peen hammer. If any of the brass port threads are stripped or damaged you're better off finding another valve. If your valve passes the exterior inspection you're ready to disassemble it and inspect the internal parts.

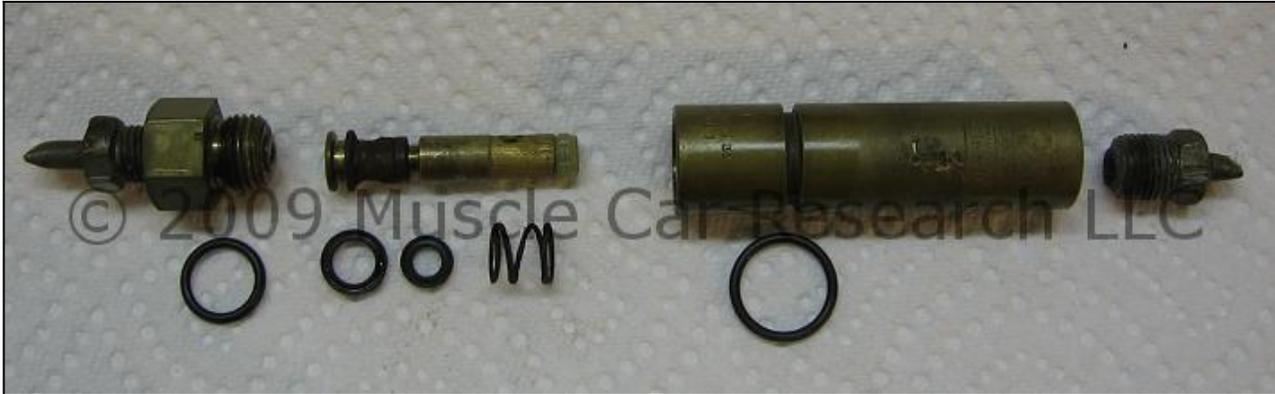
Here's what you can expect to find after you've removed the piston, seals, and spring:

Inspect the bores once the pistons have been removed. If the bores aren't perfectly smooth you should either replace the affected valve body or have the bores professionally sleeved.

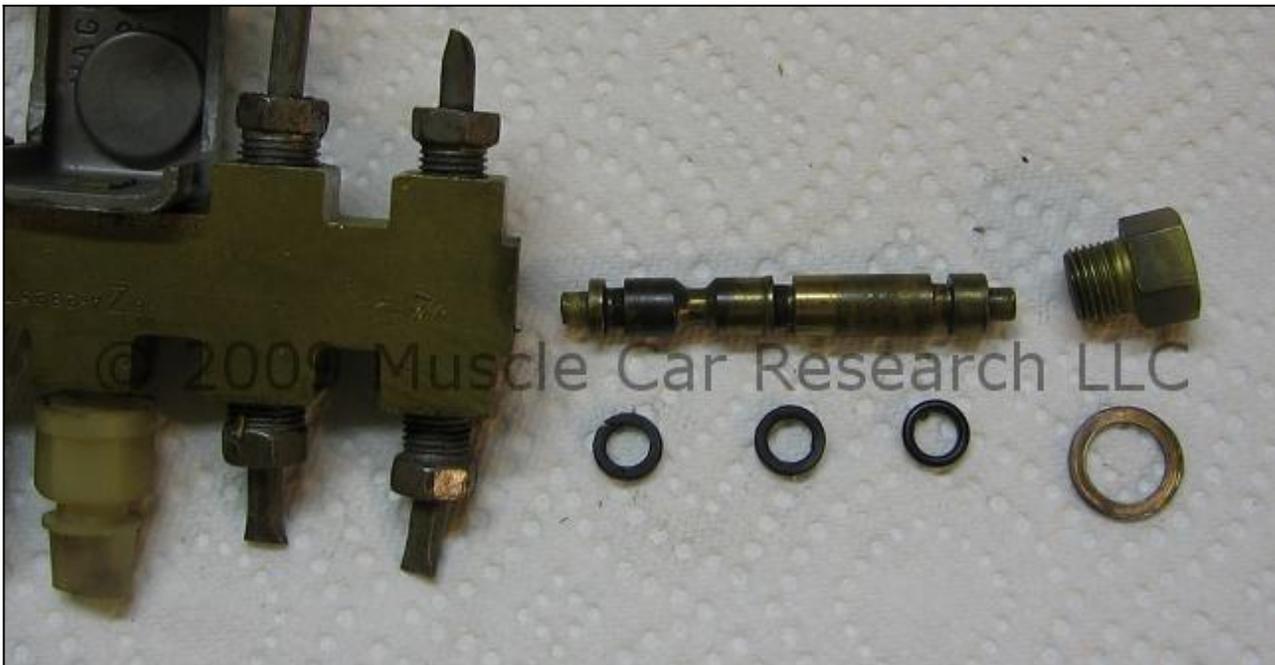
Here's the piston from inside the distribution valve:

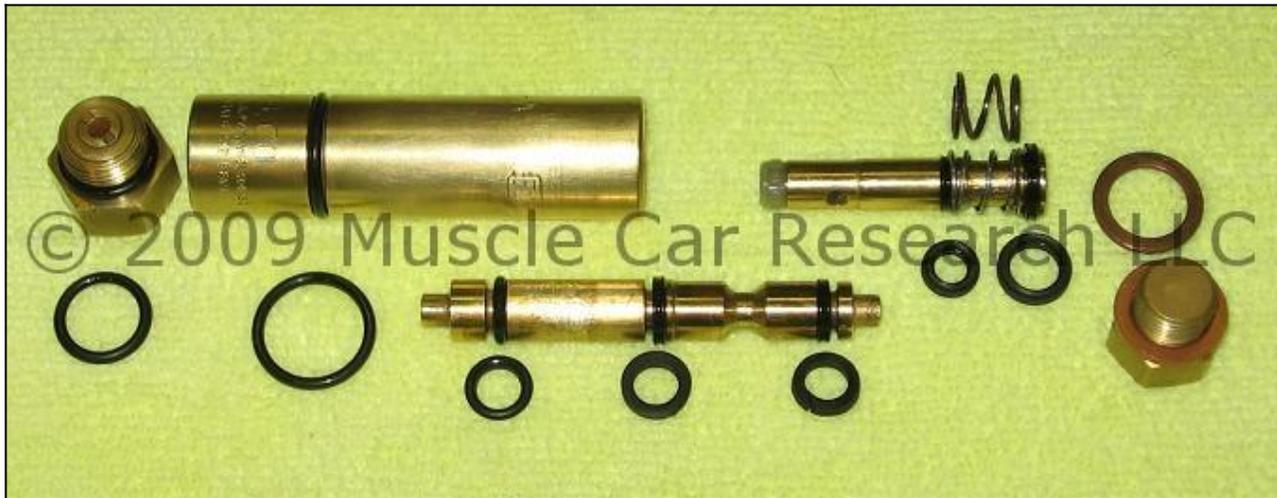
Install the new seals from the kit as shown in the picture below. Dip each seal in clean brake fluid to lubricate it prior to installation. Be careful to not twist the seals when installing them.

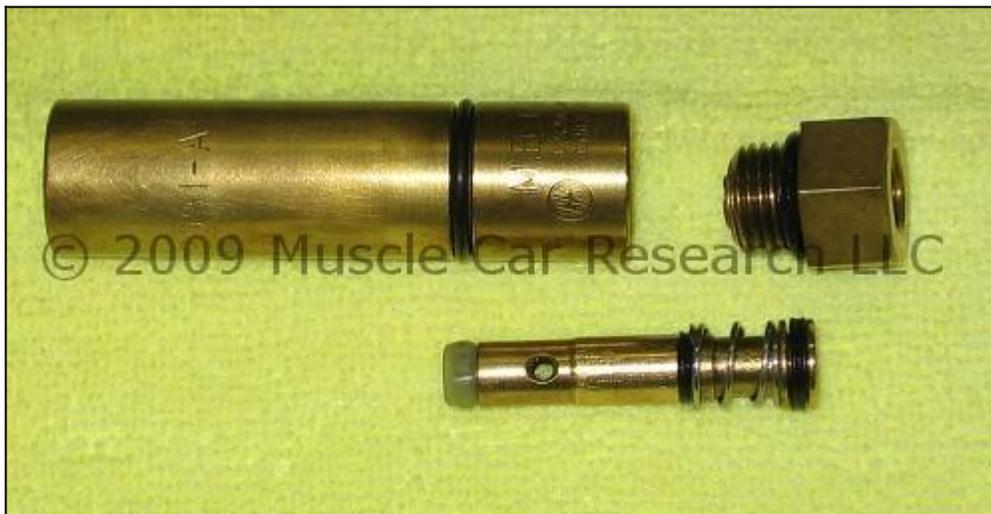
Align the piston assembly as shown in the picture below.

Lubricate the seals with brake fluid and insert the proportioning valve piston (the brass piston in the picture) into the valve body as far as it will go. *If everything is installed properly you should*

be able to move the piston in and out slightly against spring pressure. If the piston can't be moved you need to figure out why before continuing. Install the brass port on the top of the valve and tighten only enough to form a positive seal with the o-ring. Note that the large o-ring that fits on the outside of the proportioning valve covers two small weep holes. Make sure those weep holes are clean and clear.

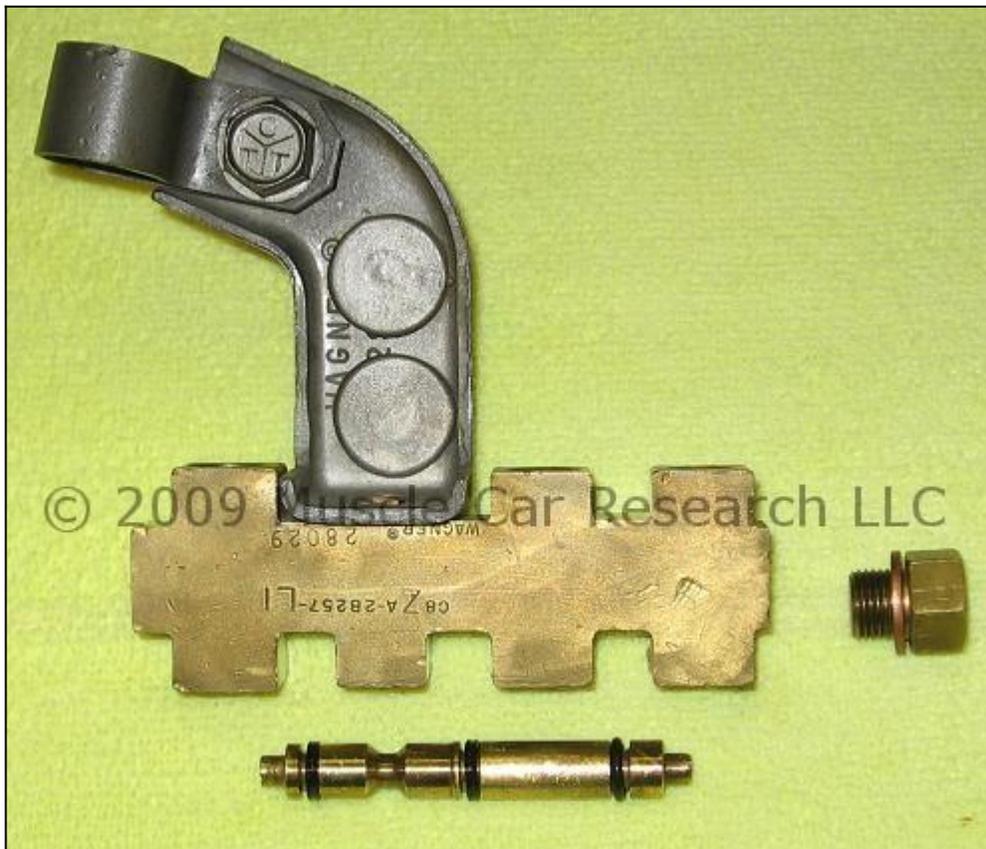
Now move to the distribution valve. Lubricate the seals with brake fluid and insert the distribution valve piston (the brass piston in the picture) only as far as it takes to align the groove in the piston with the warning lamp switch port in the valve body (the second port from left on the body in the picture). The piston should move with moderate pressure. Remove the piston and check for twisted seals if it seems too tight. The probe on the switch needs to fit in the groove without touching the sides of the groove. If you make a mistake here your brake warning lamp will be lit and you'll need to center the valve by bleeding the brakes as described in your Ford service manual.

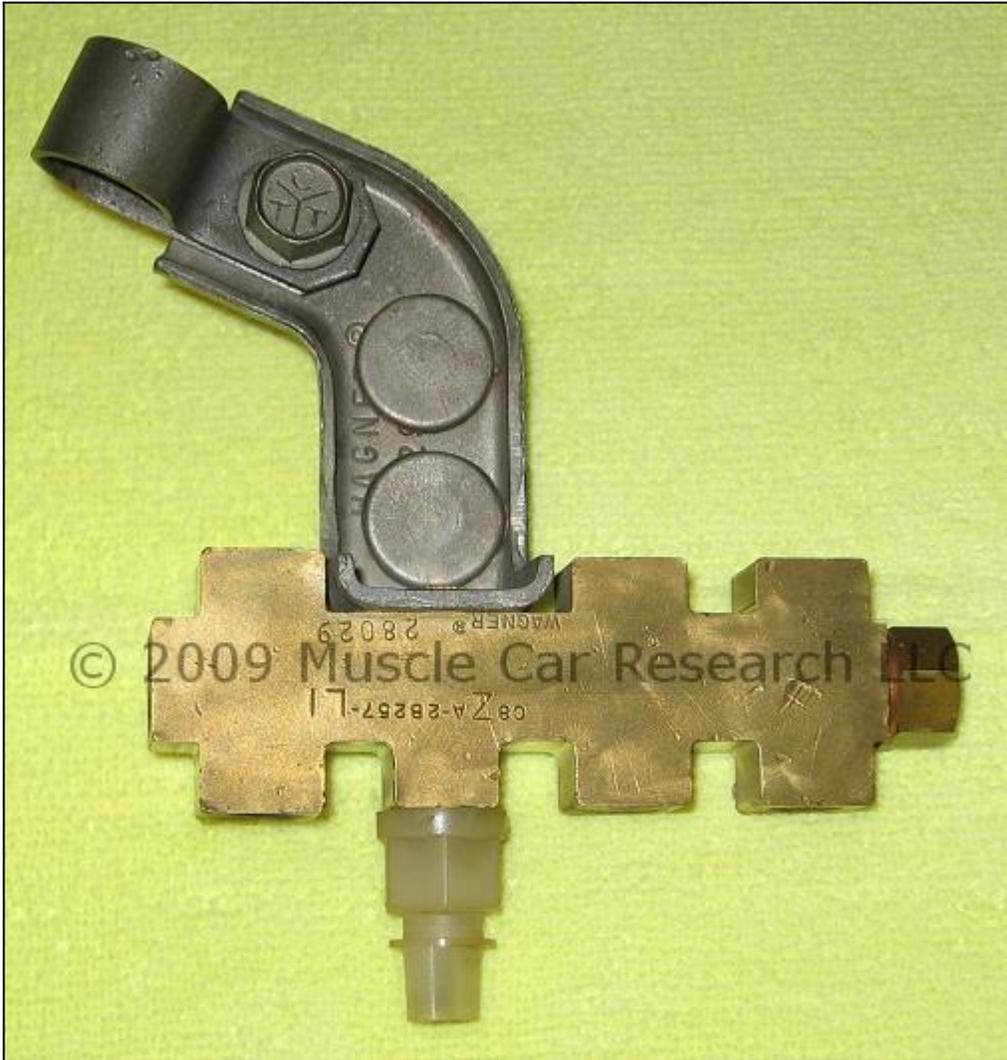
Install the brass plug on the top of the valve and tighten only enough to form a positive seal with the copper crush washer. Install the warning lamp switch.

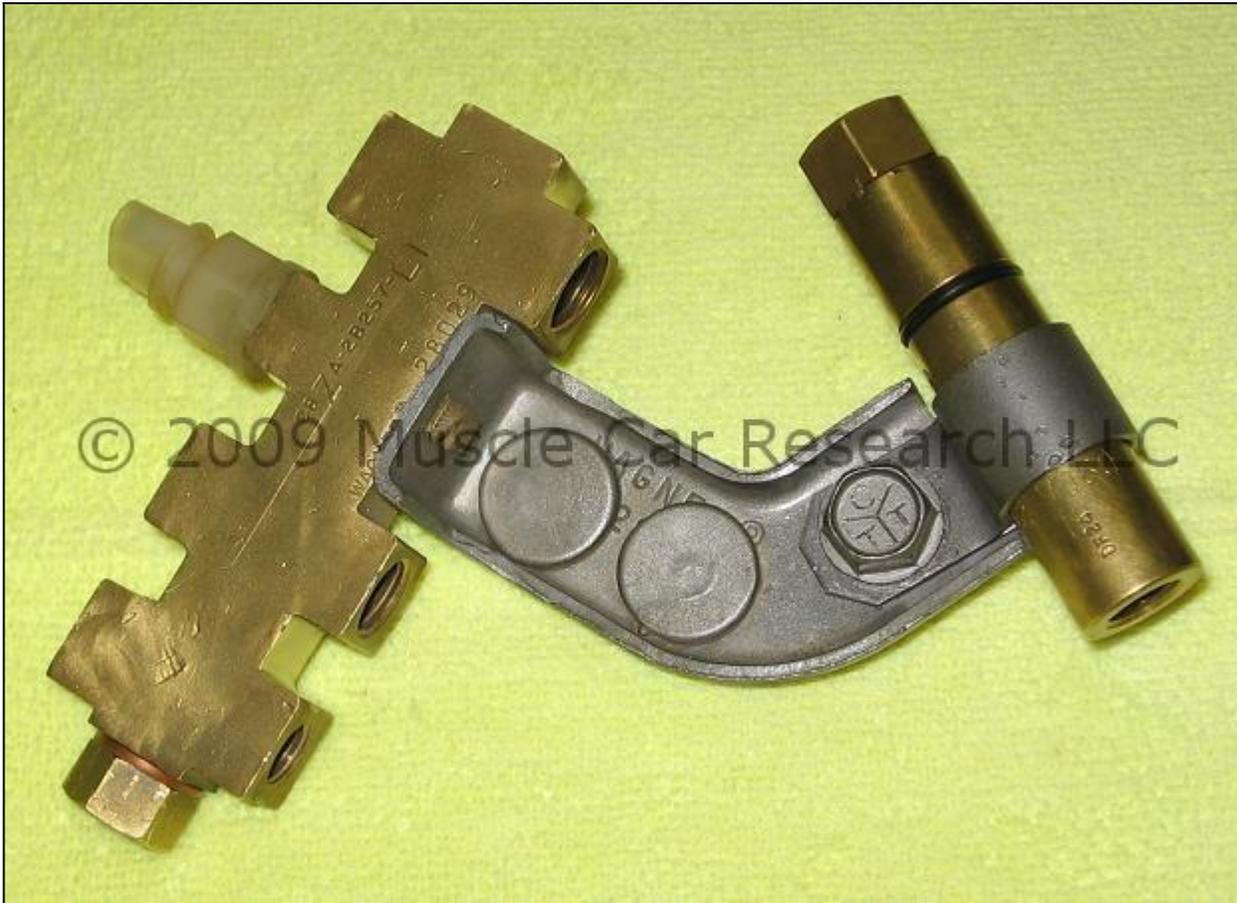
Mount the proportioning valve in the bracket and secure it by tightening the bolt. That's it! Your finished valve should look like the one pictured below.
