1970+ Ford Disc Brake Pressure Differential and Control Valve Kit

Kelsey-Hayes Brake Pressure Differential Valve Rebuild

This document describes how to rebuild the D00Z-2B257-C Kelsey-Hayes brake pressure differential valve by replacing the internal parts that typically wear out after years of service. Tools needed:

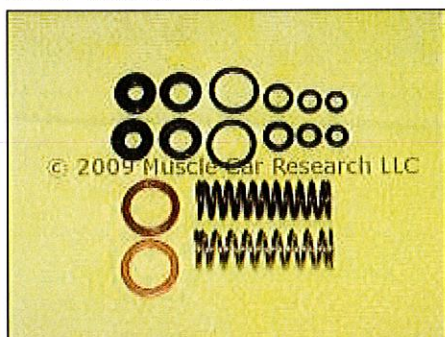
SKU: 2B257-Kit-2

Muscle Car Research is proud to offer a rebuild kit for the D00Z-2B257-C (marked D00A-2B328-D or D2ZA-2B328-AA), D0AZ-2B257-C (marked D0AA-2B328-C), D4FZ-2B257-A (marked D4ZA-2B328-AA), and D5ZZ-2B257-A (marked D5ZA-2B328-BA or D5ZA-2B328-BB) Ford disc brake combination pressure differential and rear brake pressure control valve made by Kelsey-Hayes and Wagner. Our kit contains all of the parts needed to rebuild your leaky valve and return it to "like new" operating condition, including:

- O-rings
- X-ring
- Proportioning valve seals
- Proportioning valve spring
- Copper crush washer

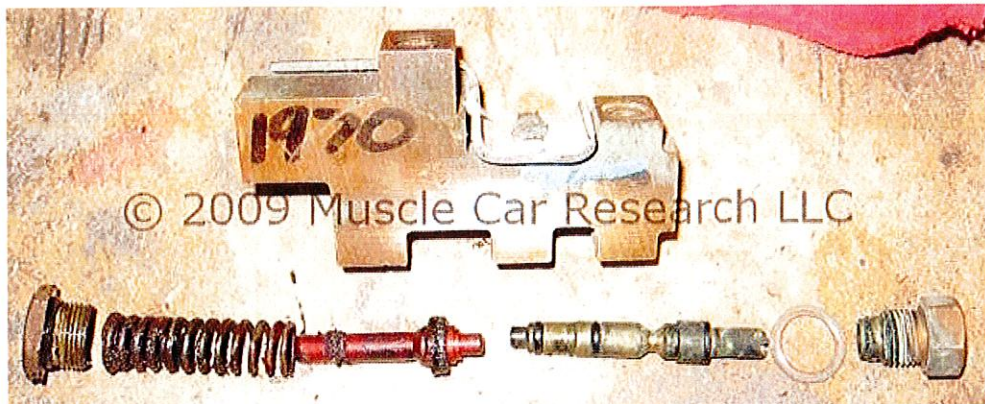
Use the wrenches or sockets to remove the brass fitting, steel plug, and the warning lamp switch. Remove the two pistons using the needle nose pliers. If the pistons don't come out easily it may help to soak them overnight with penetrating oil. Here's what you'll see (hopefully yours isn't quite so dirty):

Inspect the bores once the pistons have been removed. If the bores aren't perfectly smooth you should either replace the body or have the bores professionally sleeved.

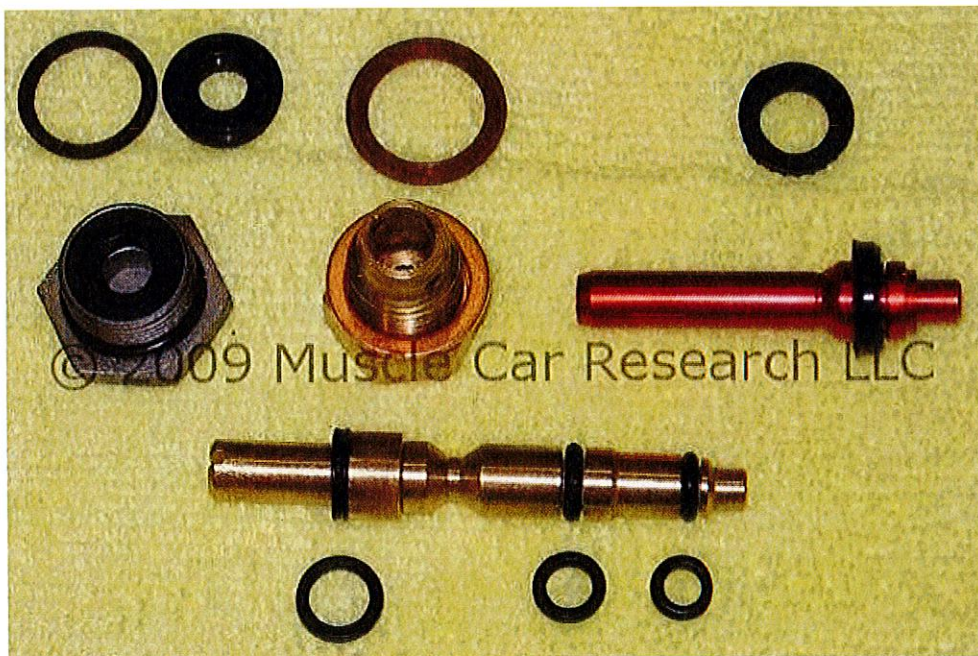
Install the new seals from the kit as shown in the picture below. Dip each seal in clean brake fluid to lubricate it prior to installation. Pay special attention to the orientation of the piston seals: if used, the u-cup that's installed in the steel plug *must* be installed facing up, and the piston seal installed on the proportioning valve piston (the red piston below) *must* be installed with the flat side towards the short end of the piston.

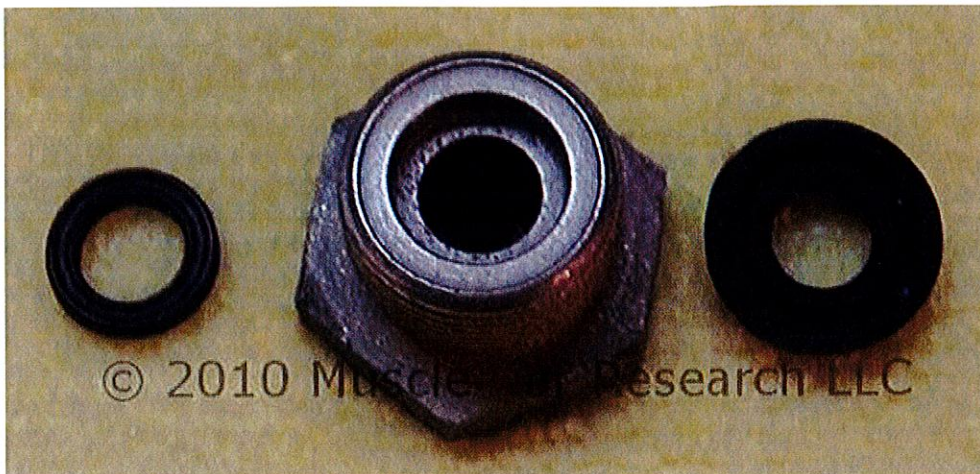
The D7DA-2B328-AB valve uses a square-cut o-ring in place of the u-cup seal found in the earlier valve. The rebuild kit sold by Muscle Car Research replaces the square-cut o-ring with a quad ring that provides two sealing surfaces instead of one. The difference in the two seal types is shown in the picture below.

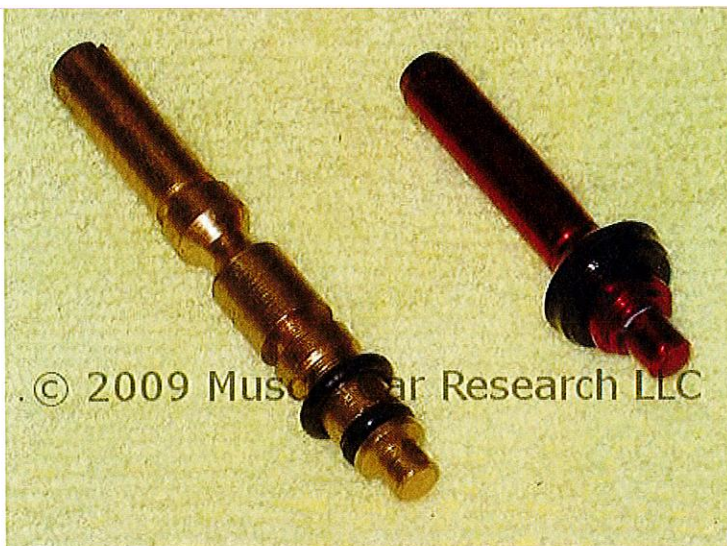
I find it easier to install the middle o-ring on the distribution block piston (the brass piston below) after first installing the small end o-ring. The small ring then acts as a bridge so the middle ring doesn't get caught in the small ring groove. Note the order of the rings: x-ring on the left, medium-sized o-ring in the middle, and smallest o-ring on the right.

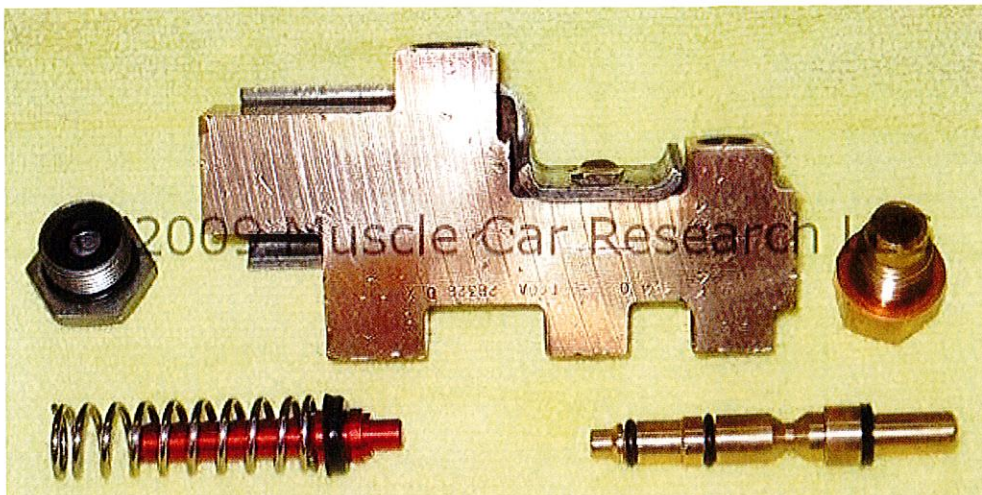
Align the piston assemblies as shown in the picture below. Insert the proportioning valve piston (the red piston in the picture) as far as it will go.

Insert the distribution block piston (the brass piston in the picture) only as far as it takes to align the groove in the piston with the warning lamp switch port in the valve body (the middle port on the body in the picture). The probe on the switch needs to fit in the groove without touching the sides of the groove. If you make a mistake here your brake warning lamp will be lit and you'll need to center the valve by bleeding the brakes as described in your Ford service manual. Install the brass port on the top of the valve and tighten only enough to form a positive seal with the copper crush washer.

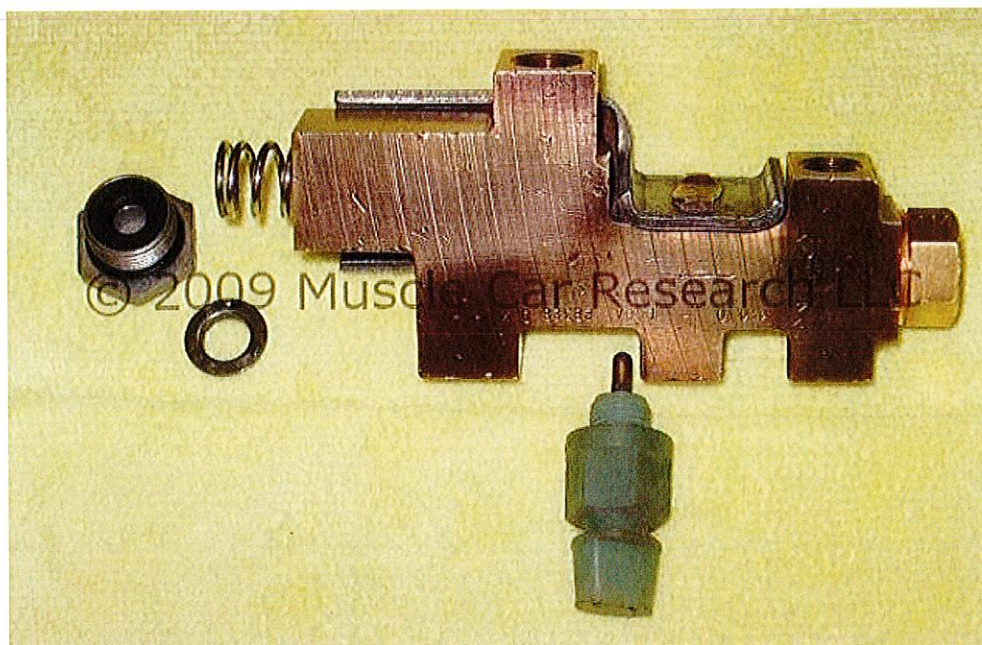
Install the spring behind the proportioning valve piston. Place the metal spring cap on top of the spring (the ridges on the cap fit *inside* the spring) and install the steel plug. Tighten the plug only enough to form a positive seal with the o-ring. Install the warning lamp switch.

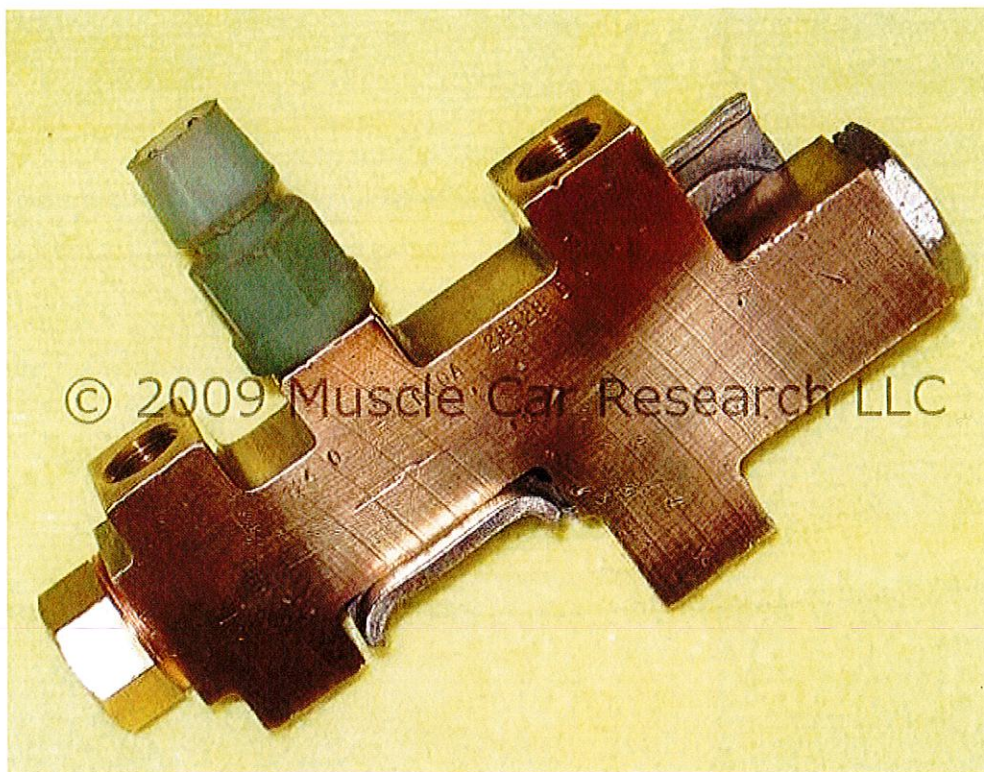
That's it! Your finished valve should look like the one pictured below.
